Testing of Tapco Slate

– Reporting of deemed-to-satisfy requirements

CLIENT REFERENCE	Request S. Yeates
OUR REFERENCE	BEL0711-2
INVESTIGATING OFFICER	James P. Mann & Graham Baggs
REPORT PREPARED BY	James P. Mann

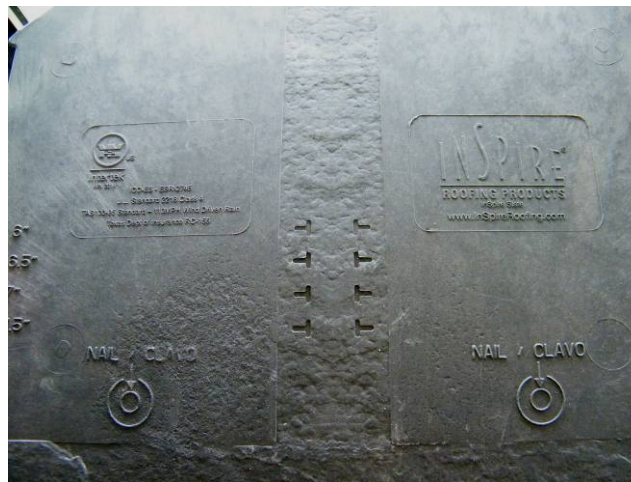
Plate 1: Front view of tile showing manufacturer’s details. Note fixing locations.

Typical permanent markings on the tiles are shown in Plates 1 and 2 below.

Based on the markings on the samples supplied, the Tapco Slate tiles can be deemed to satisfy the Marking requirements of Section 9 of AS2049:2002 for roof tiles.

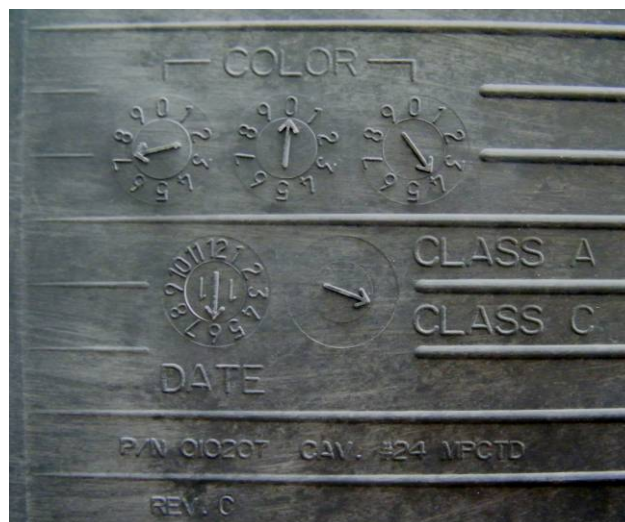
Plate 2: Rear view of tile showing manufacturing date and colour batch details.
